# CONFIDENTIAL INSPECTION REPORT

LOCATED AT:  
123 Hawaiian Loop  
Sarasota, Florida 34242

INSPECTED ON:  
Friday, March 10, 2017

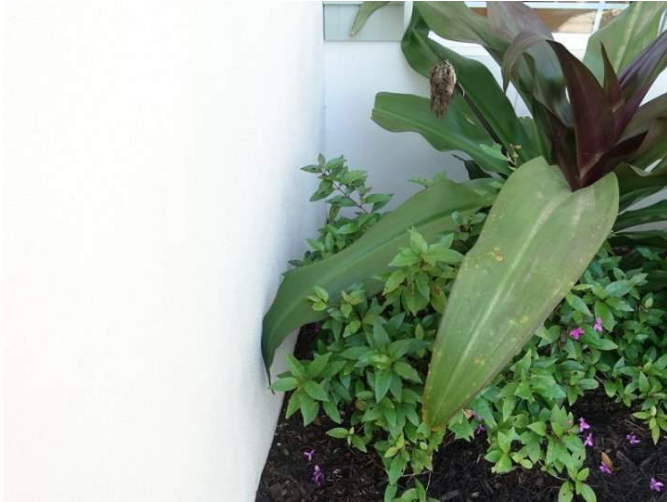
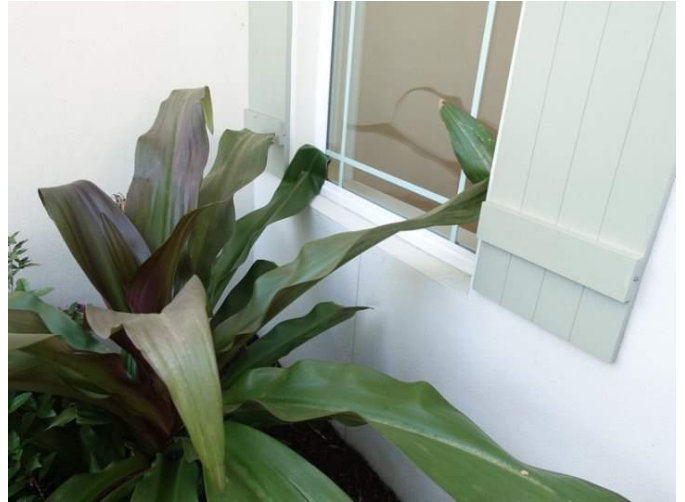
Recommend trimming back bushes to allow for ventilation and reduce abrasion of the home's exterior.

1: - Recommend trimming back bushes to allow for ventilation and reduce abrasion of the home's exterior.

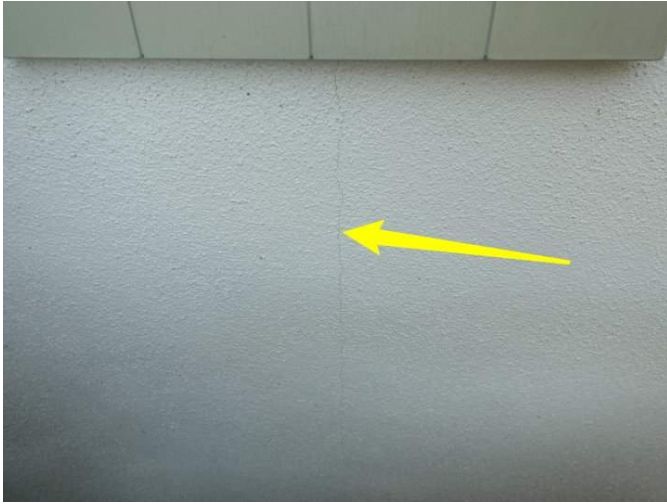
Exterior walls inspected. Common settlement cracking observed.

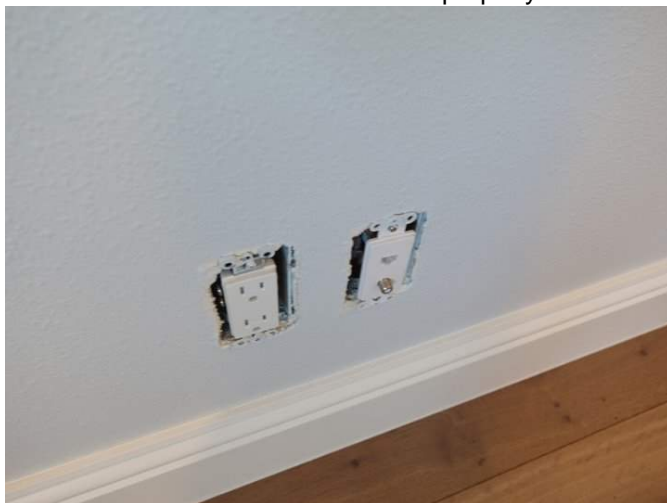
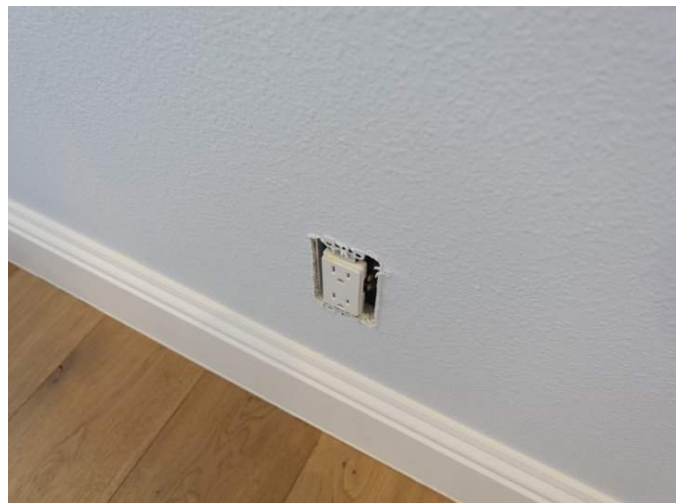
Several front right guest bedroom outlets were missing faceplate covers. Painting in progress. Recommend all electrical outlets and connections be properly covered.

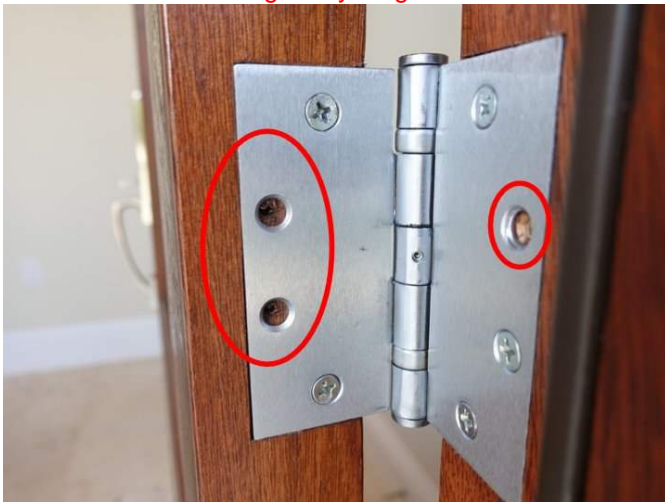
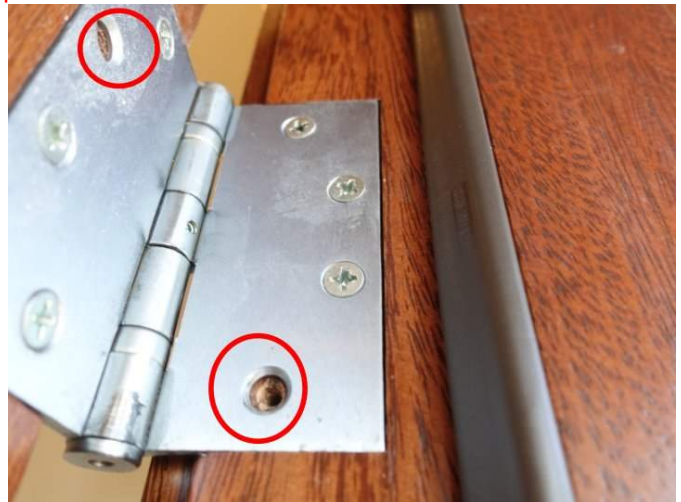
Front door was missing many hinge screws. Recommend repairs.

2: - Front door was missing many hinge screws. Recommend repairs.

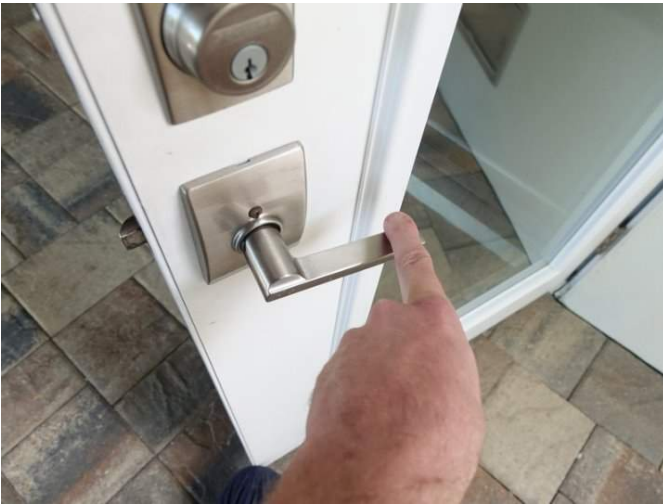
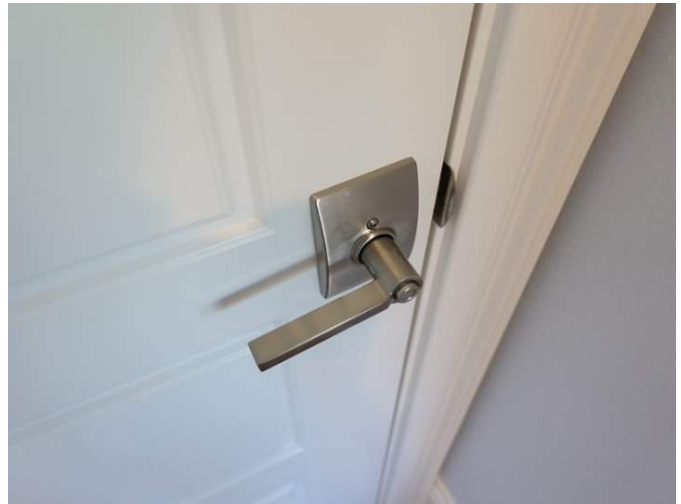
Several downstairs exterior doors and upstairs interior doors had wobbly door handles. Recommend handyman service.

3: - Several downstairs exterior doors and upstairs interior doors had wobbly door handles. Recommend handyman service.

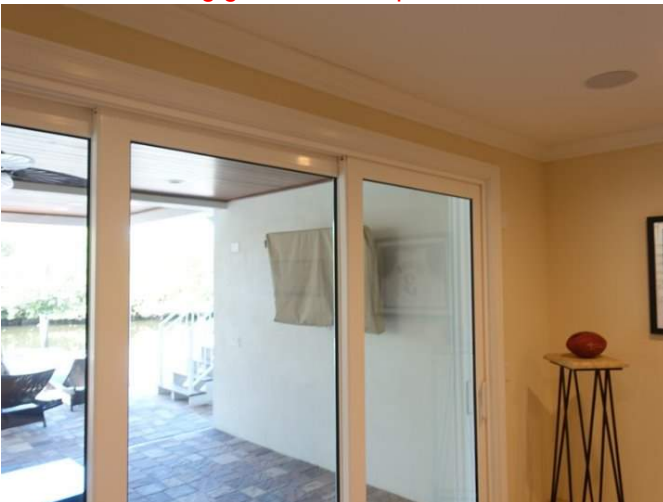
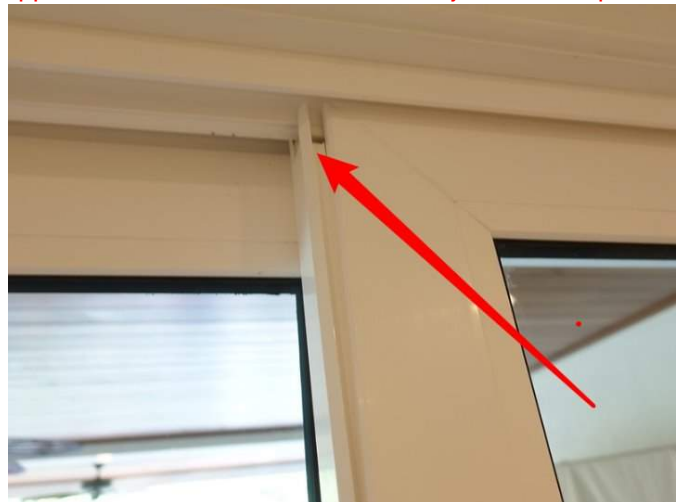
Downstairs sliding glass doors to pool area had an area of popped out frame trim. Recommend adjustment / repair.

4: - Downstairs sliding glass doors to pool area had an area of popped out frame trim. Recommend adjustment / repair.

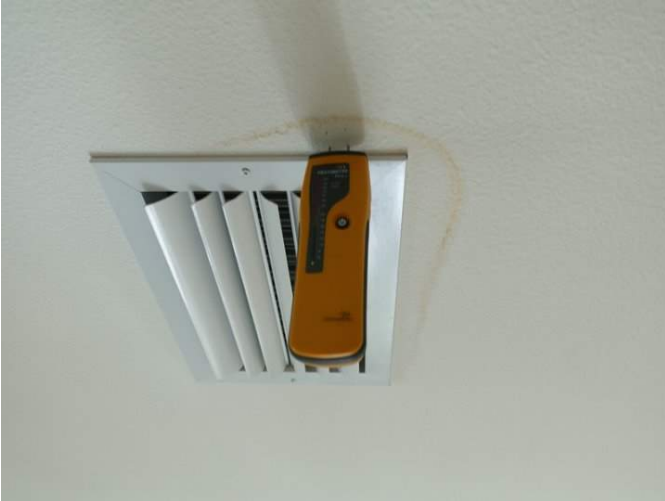
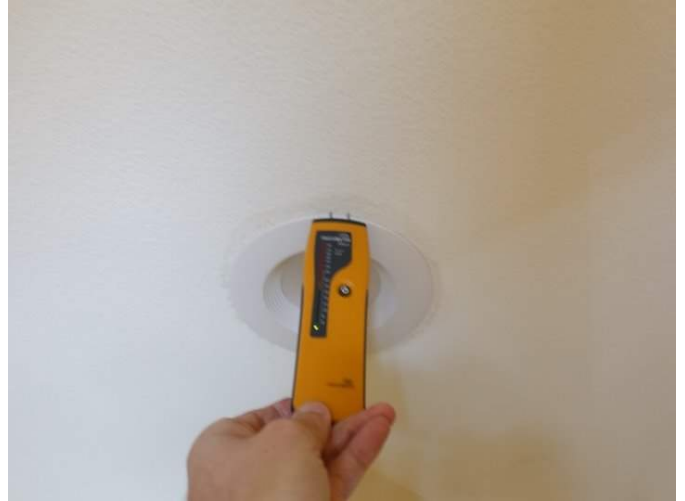
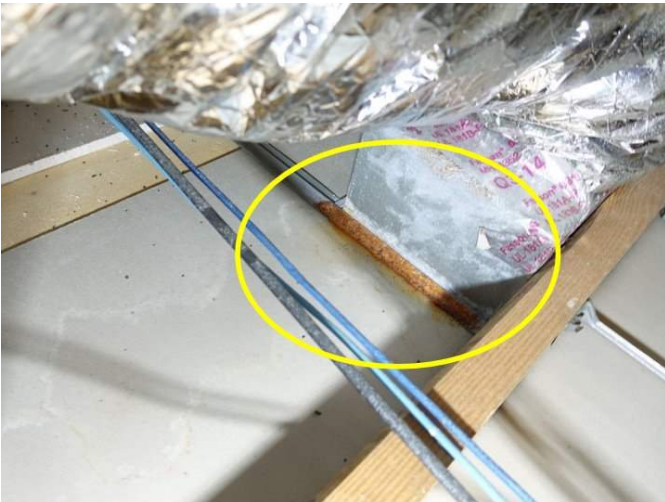
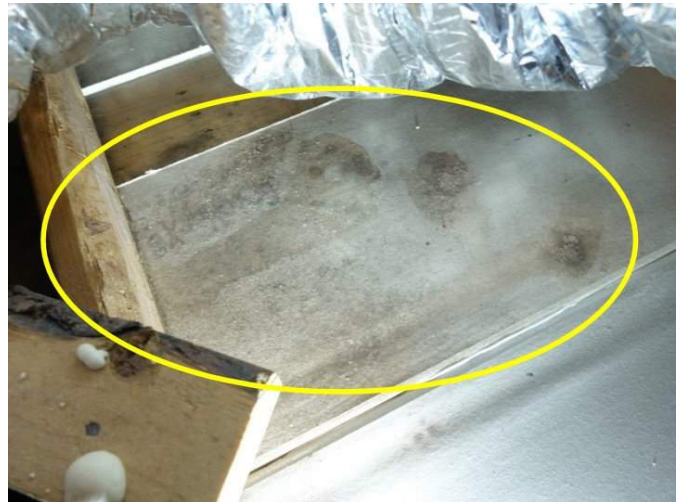
Dry moisture staining was noted at the front guest bed/bath ceiling vents & closet light. Also, staining / discoloration was observed around the vent in front right bath. Moisture staining was seen in the attic around the vents and at some drywall. Recommend further evaluation of ductwork by a qualified HVAC contractor for any servicing or repairs deemed necessary.

5: - Dry moisture staining was noted at the front guest bed/bath ceiling vents & closet light. Also, staining / discoloration was observed around the vent in front right bath. Moisture staining was seen in the attic around the vents and at some drywall. Recommend further evaluation of ductwork by a qualified HVAC contractor for any servicing or repairs deemed necessary.

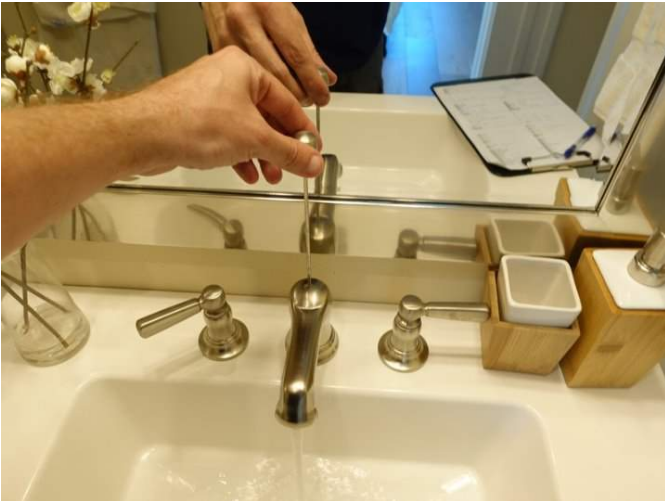
Sink stopper at the front left bathroom did not operate. Recommend repair.

6: - Sink stopper at the front left bathroom did not operate. Recommend repair.

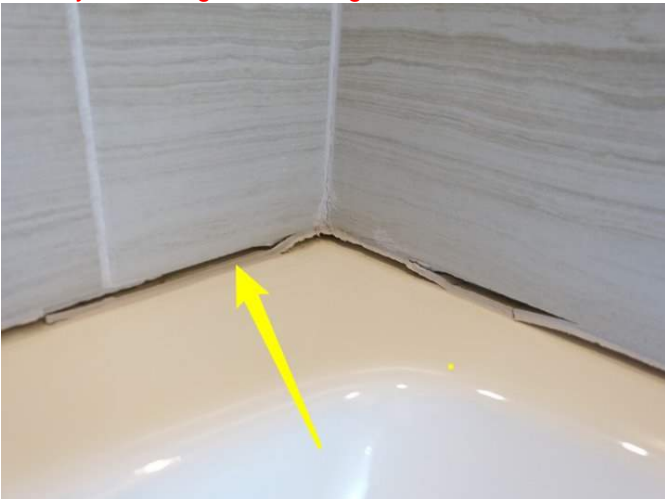
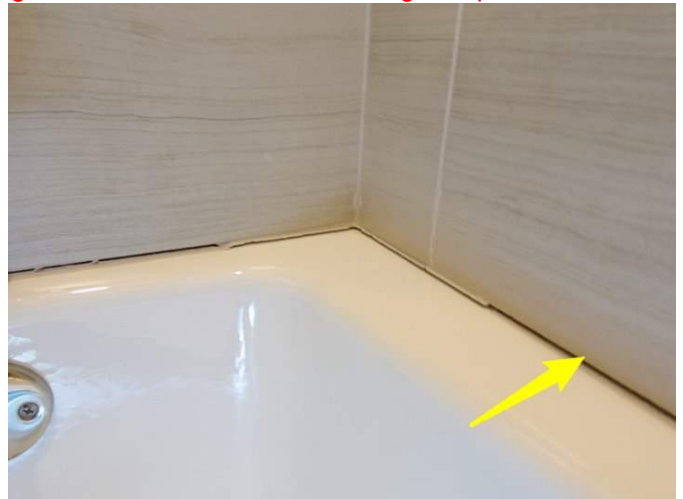
Heavily cracked grout/caulking was noted at the front left & right bathtubs. Recommend sealing or repairs as needed.

7: - Heavily cracked grout/caulking was noted at the front left & right bathtubs. Recommend sealing or repairs as needed.

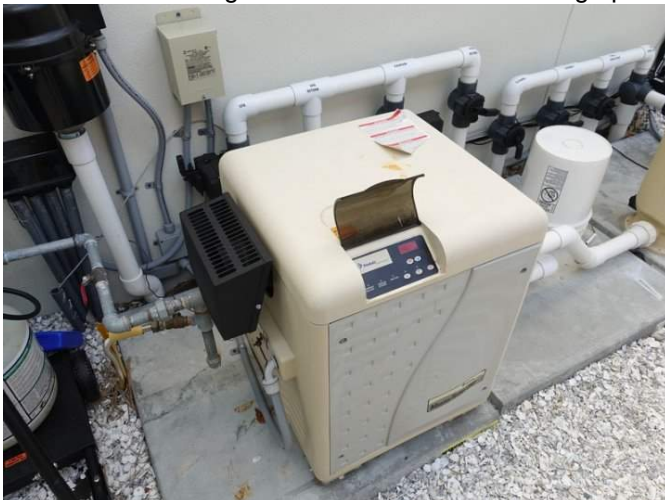
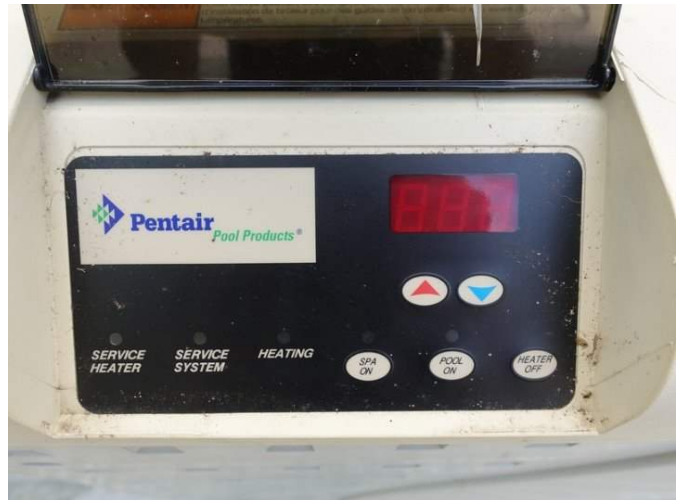
Pool heater appeared in serviceable condition. No thermostatic controls were found to evaluate heating function. Recommend asking seller to demonstrate heating operation.

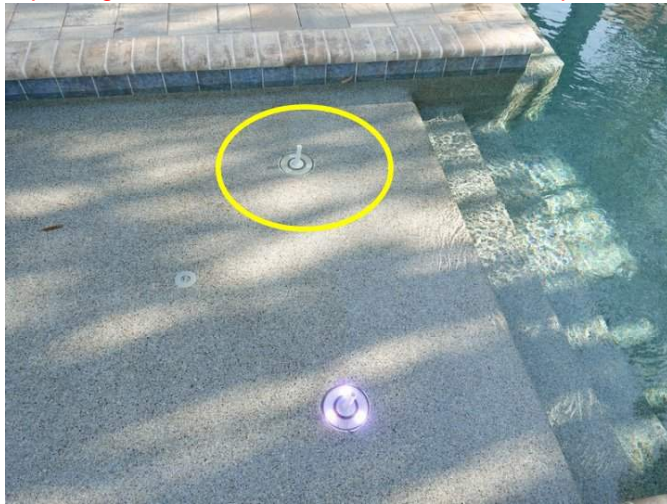
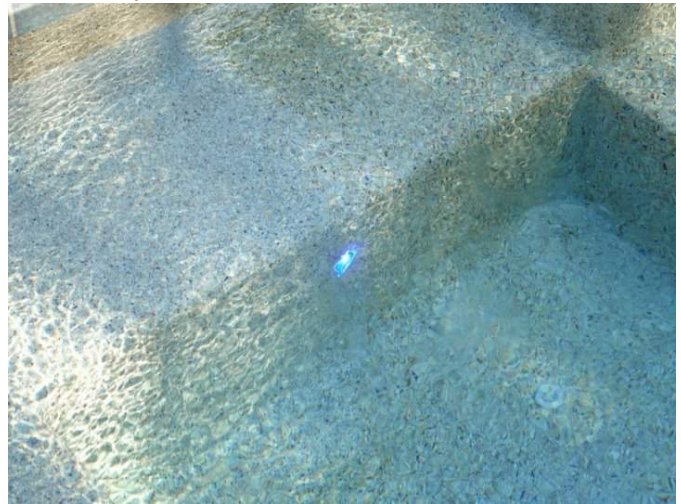
A pool light was not functional at the time of inspection. Recommend repairs.

8: - A pool light was not functional at the time of inspection. Recommend repairs.
