# CONFIDENTIAL INSPECTION REPORT

LOCATED AT:  
123 Hawaiian Loop  
Sarasota, Florida 34242

INSPECTED ON:  
Friday, March 10, 2017

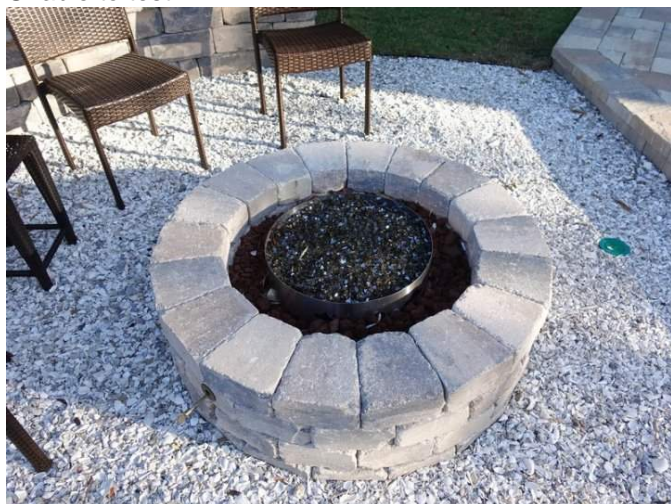
## FIREPLACE(S)

Patio gas fireplace pilot light was not on. Gas supply could be heard. Ask seller if fireplace is on a remote control. Unable to test.

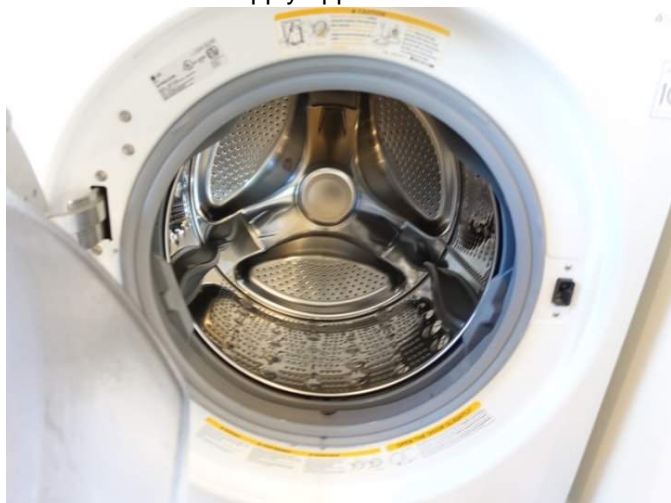
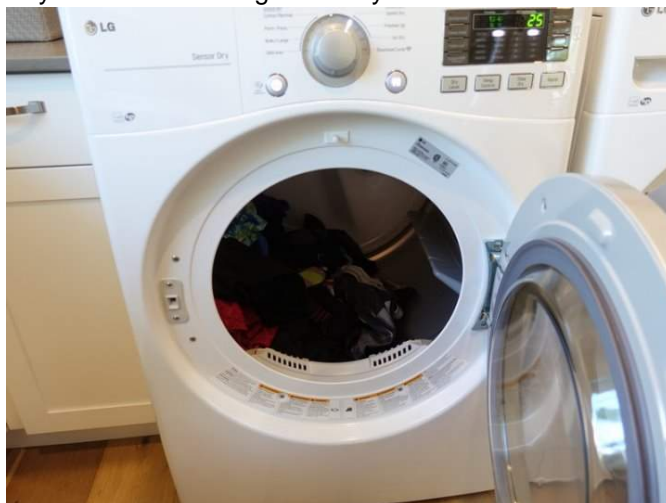
## LAUNDRY

Water & electrical supply appeared serviceable. Washer and dryer were run through short cycle. Tested ok.

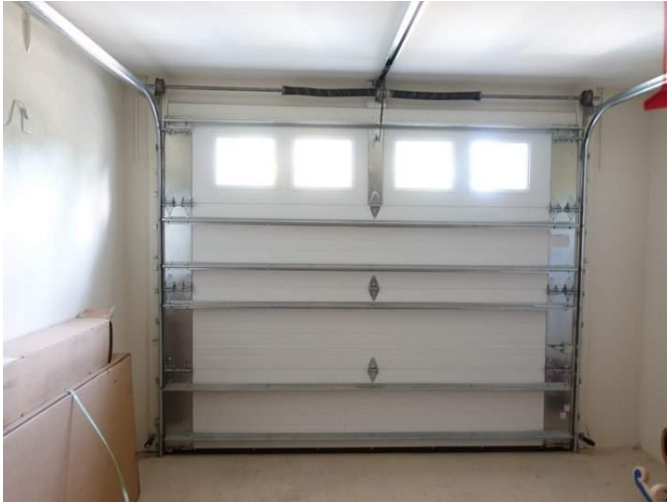
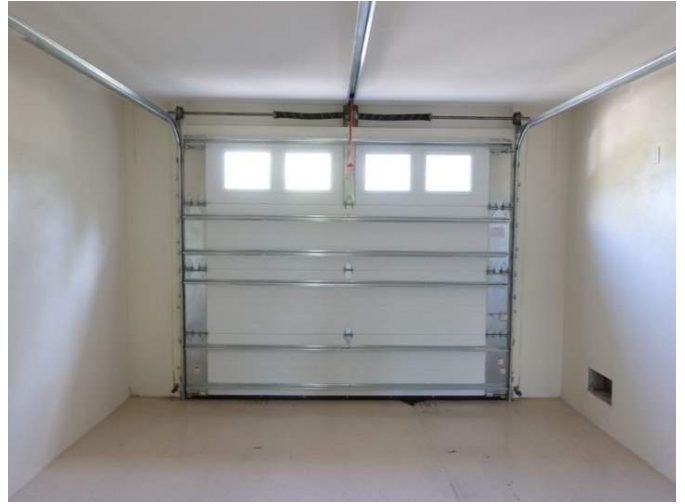
### **GARAGE AUTOMATIC DOOR OPENER**

Automatic garage door openers responded to test.

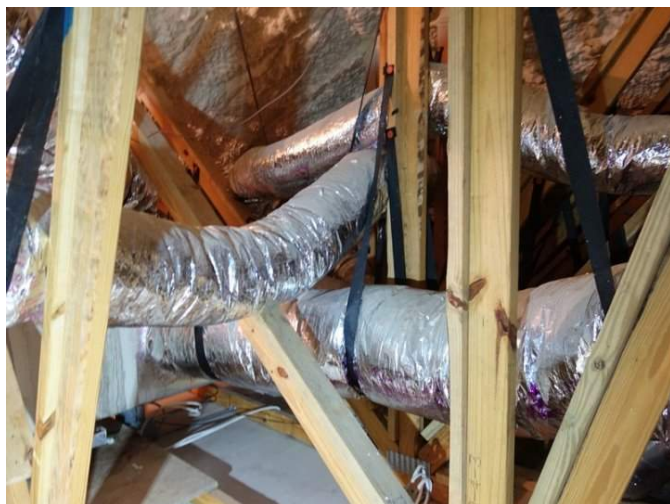
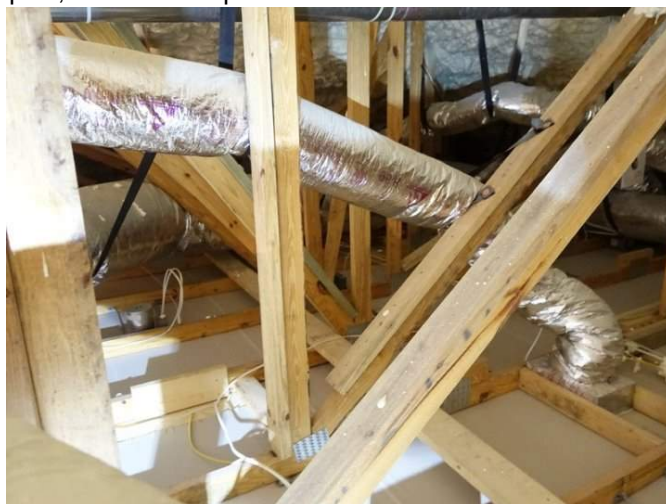
### INSPECTION ACCESS

Entered - Attic had limited access due to construction techniques, areas of low pitch and insulation.

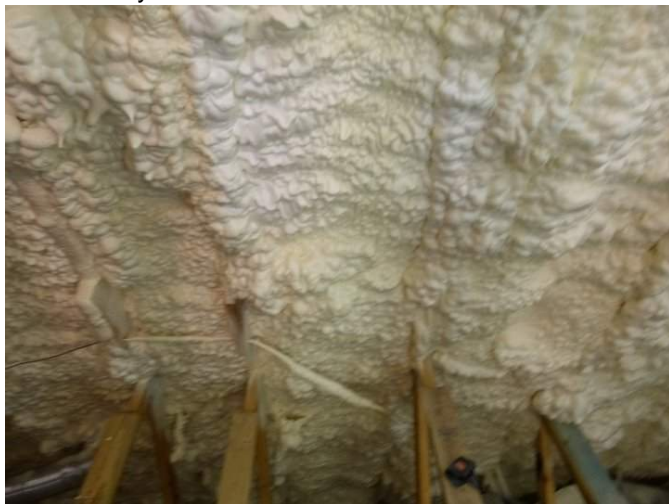
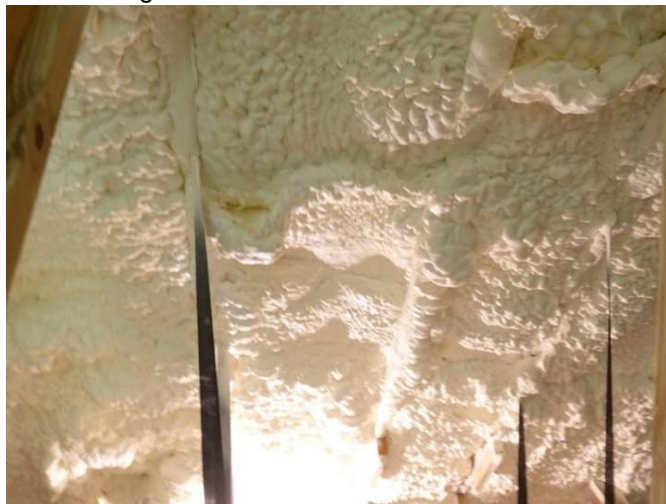
## INSULATION

Attic had Icynene insulation installed which limits view of the roof decking.

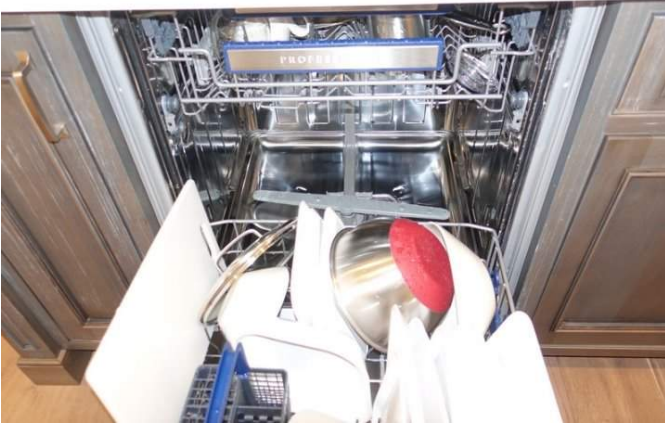
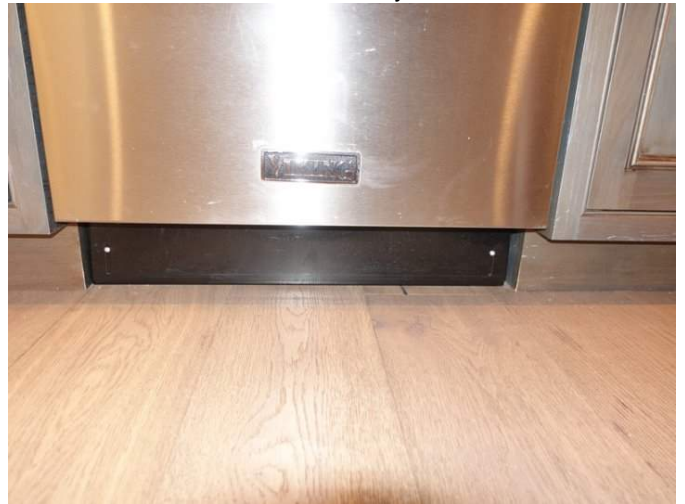
Dishwasher was run through a standard cycle. Completed. No visible moisture at base after cycle.

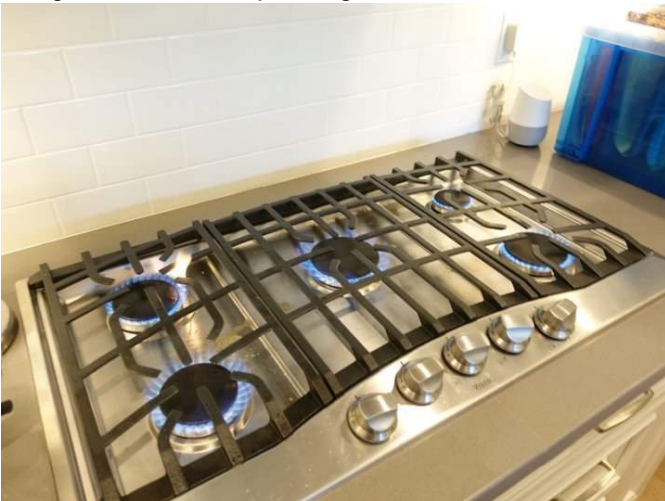
Range & oven were operating.

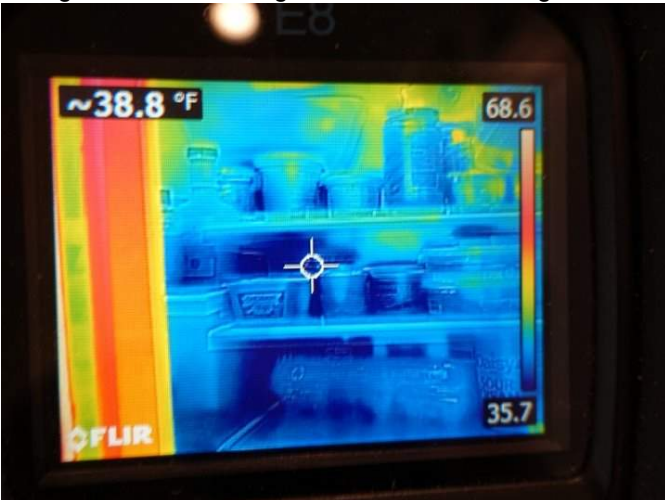
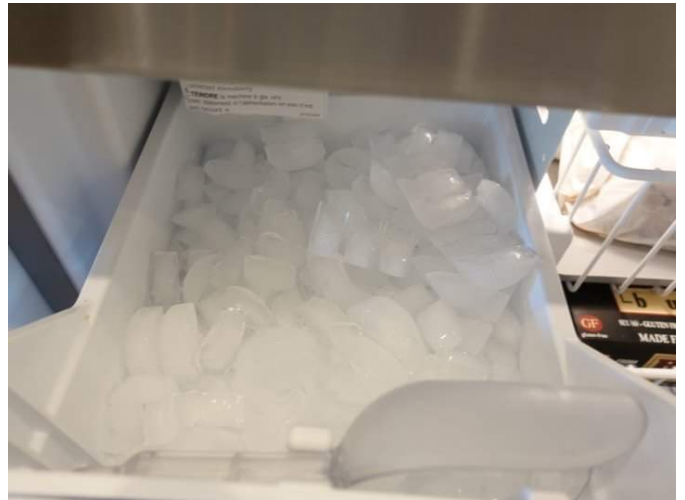
Refrigerator was cooling. Freezer was freezing. OK

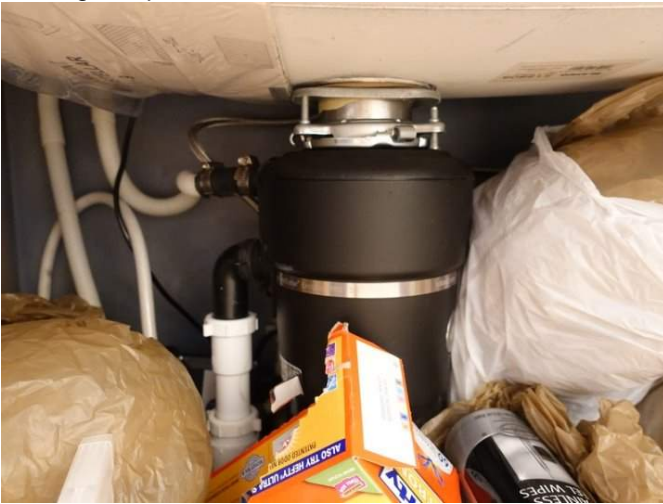
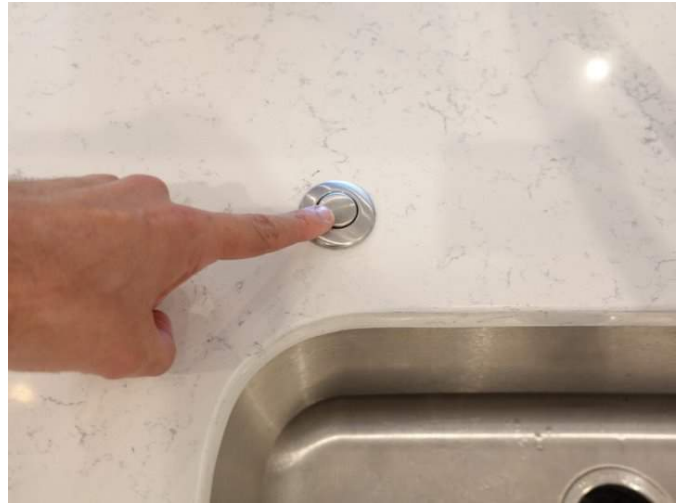
### DISPOSAL

Garbage disposal tested ok.

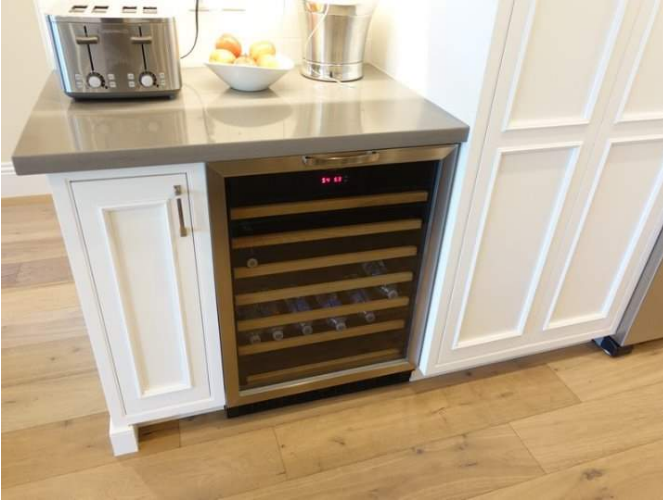
Refrigerator and freezer were cooling at time of inspection.

Wine refrigerator was cooling.

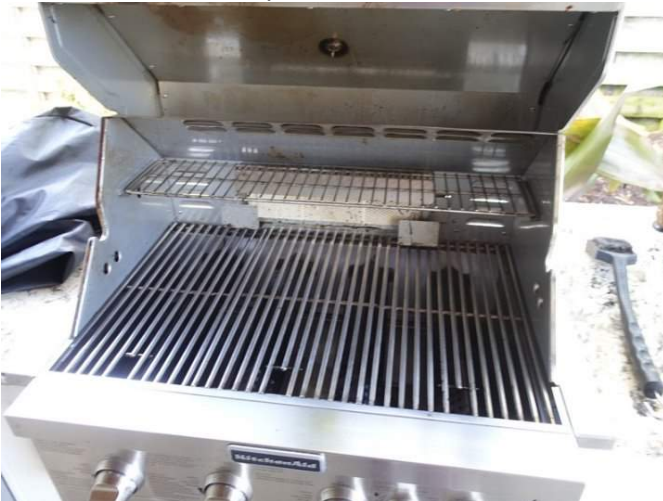
## MICROWAVE

Microwave responded to test.

BBQ on back deck responded to test.

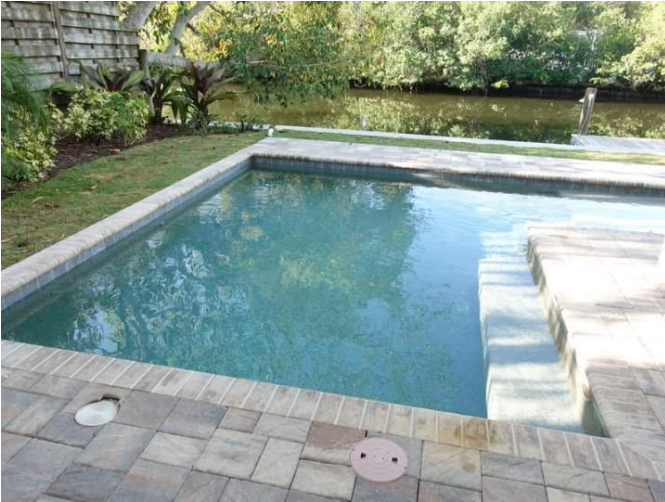
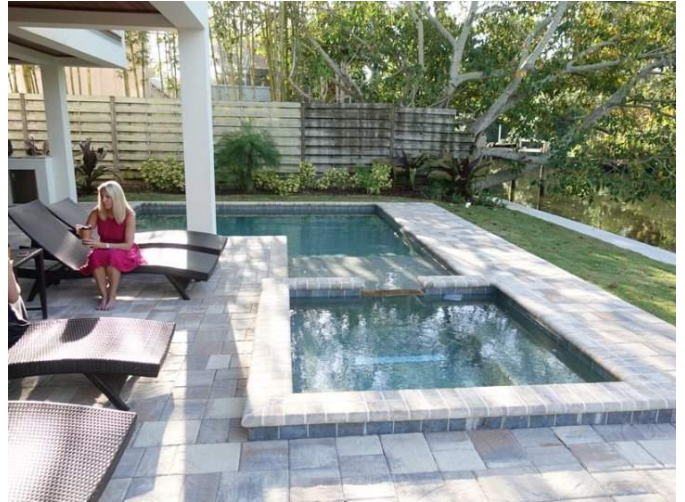
### BODY

Pebblestone

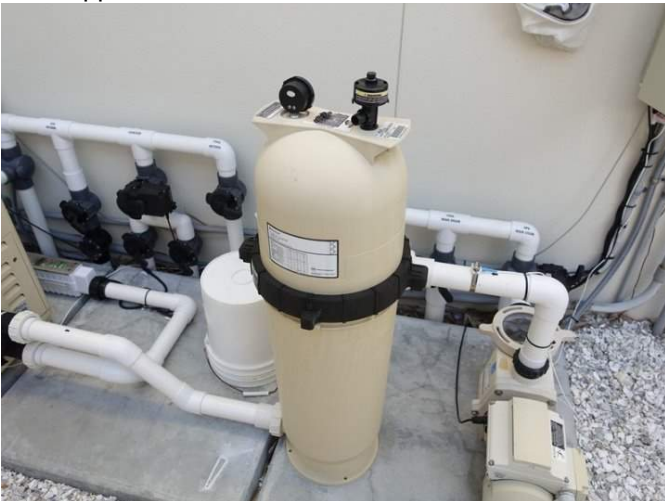
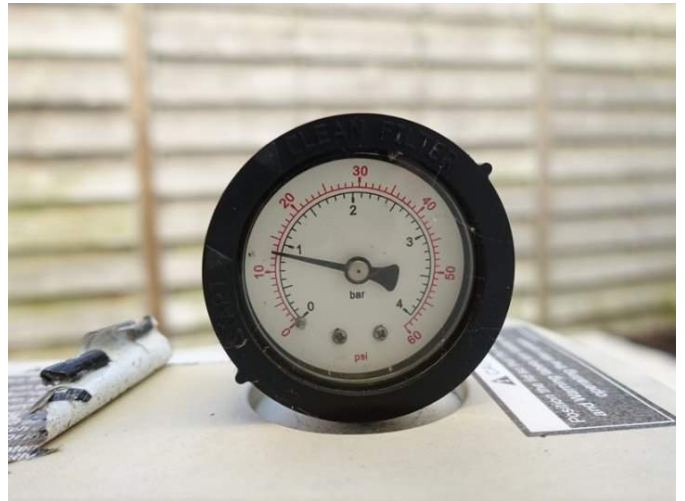
### FILTER

Filter appeared serviceable.

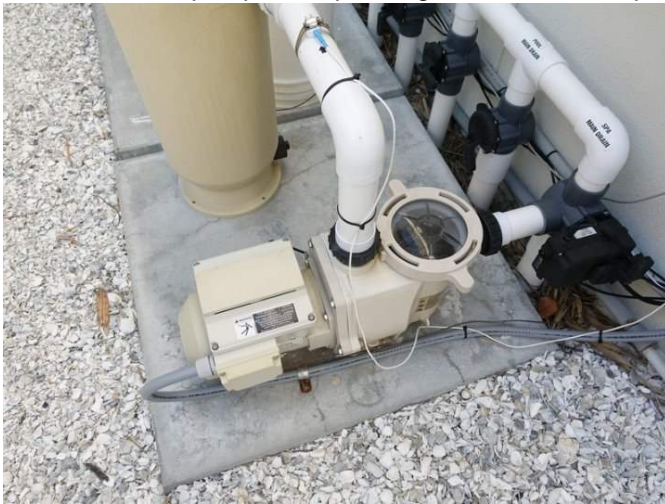
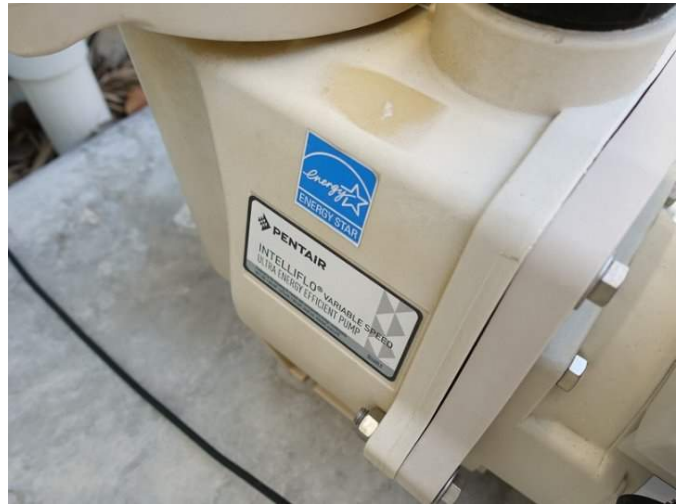
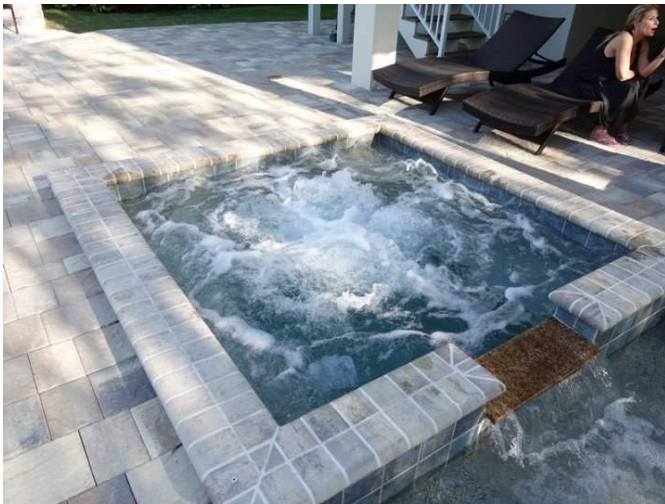
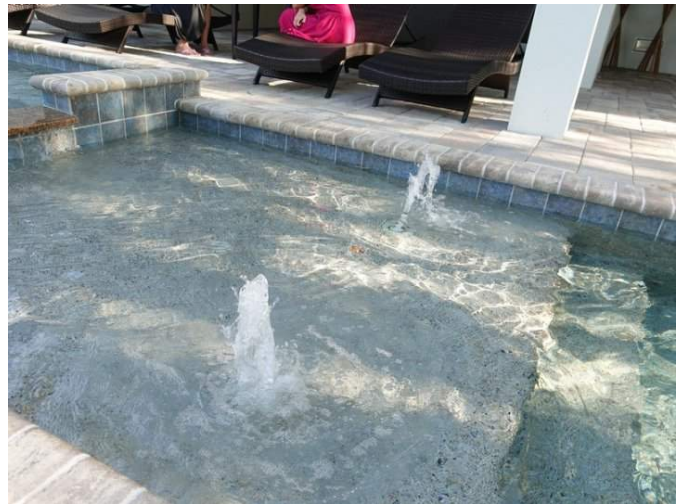
## PUMPS

Pool circulation pump was operating at the time of inspection.
